# 2023 Data Report for Lake Mecosta, Mecosta County

Site ID: 540057

# Lake Mecosta, Mecosta County 2023 CLMP Results

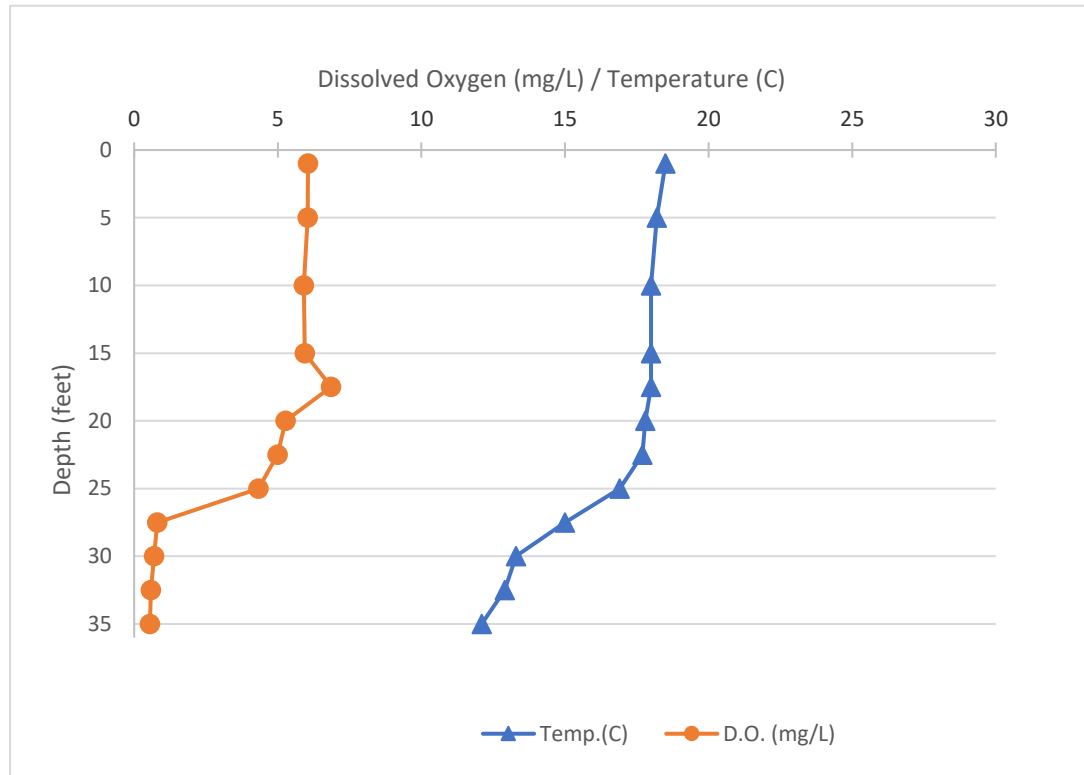
9/14/2006

### Dissolved Oxygen and Temperature Profile

Depth (ft)	Temp.(C)	D.O. (mg/L)
1	18.5	6.05
5	18.2	6.04
10	18	5.91
15	18	5.94
17.5	18	6.86
20	17.8	5.27
22.5	17.7	4.99
25	16.9	4.32
27.5	15	0.8
30	13.3	0.69
32.5	12.9	0.58
35	12.1	0.55
